**PLEASANT VALLEY RECREATION & PARK DISTRICT
1605 EAST BURNLEY STREET, CAMARILLO, CONFERENCE ROOM**

**LIAISON COMMITTEE
AGENDA**

Phase I Environmental Site Assessment

**Subject: Phase I Environmental Site Assessment
1605 E. Burnley Street
Camarillo, California**

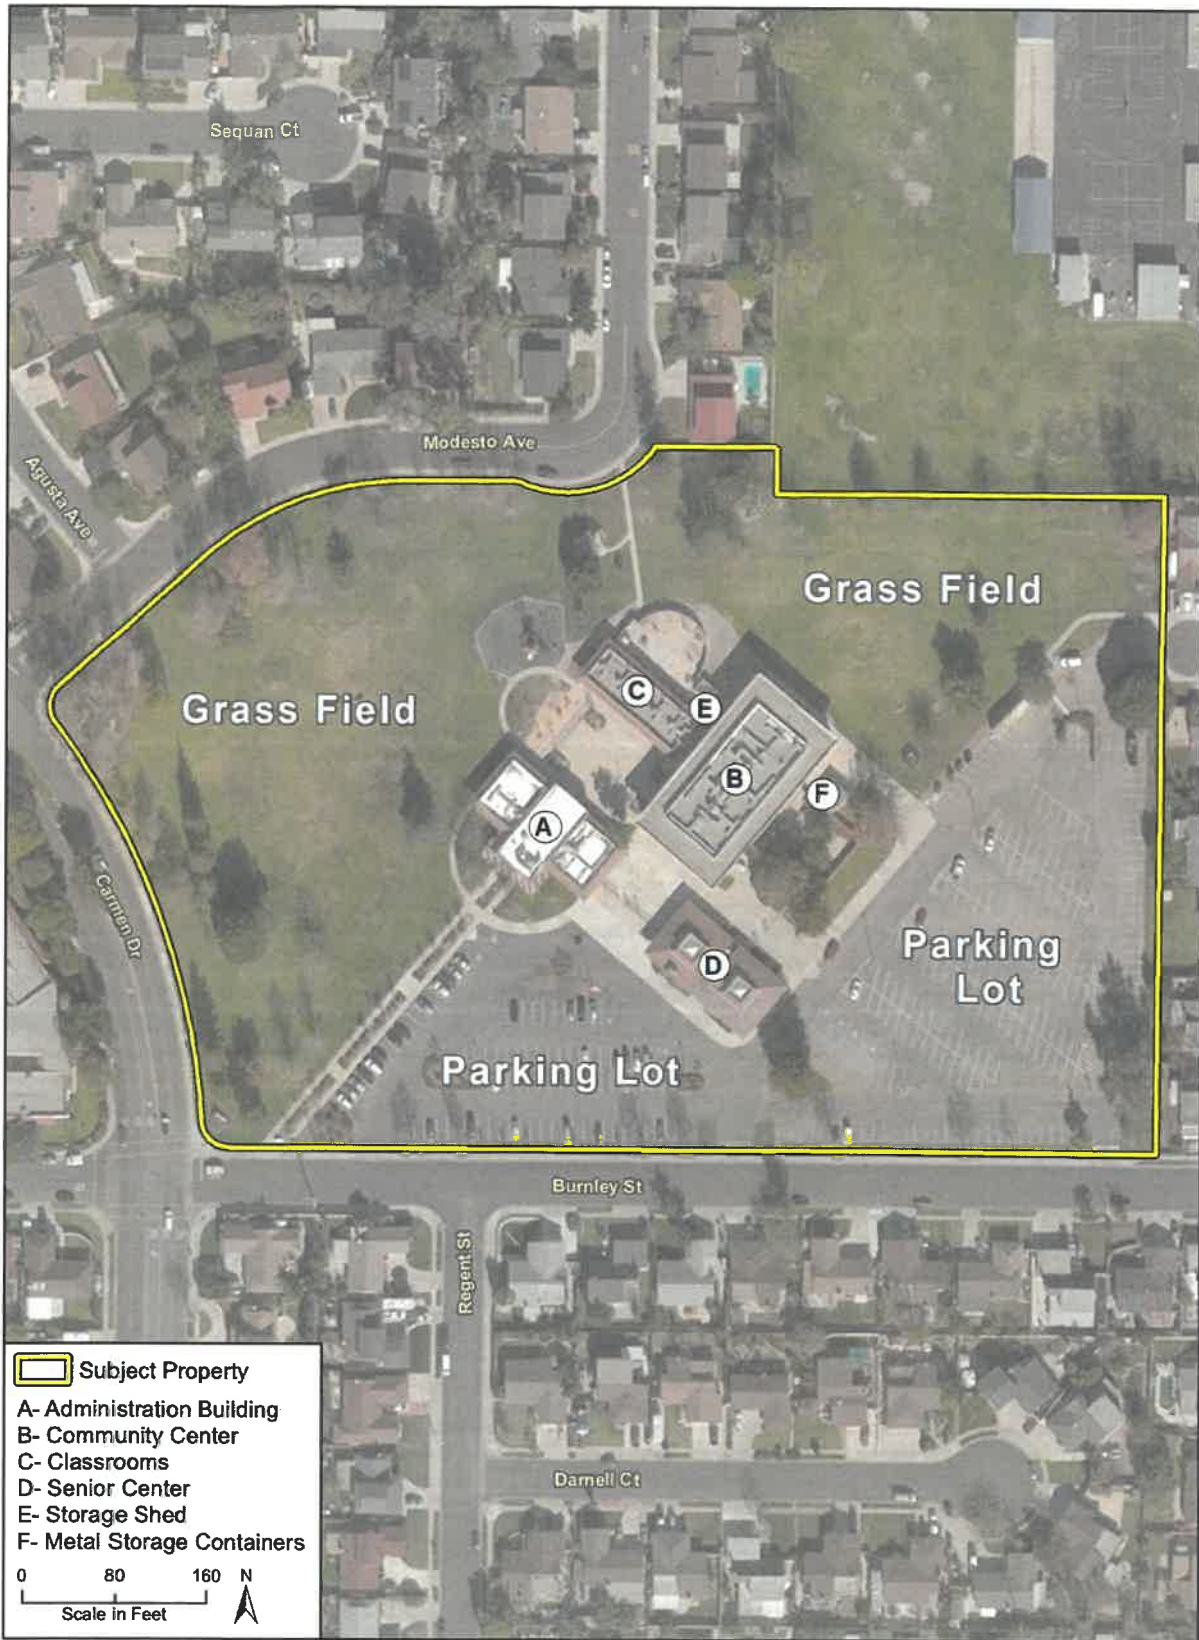
Figure 2

The subject property is a 11.48 -acre parcel located east of Carmen Drive, north of Burnley Street and south of E. Modesto Avenue in Camarillo, California (Figure 2, Site Map). The property is identified as 1605 E. Burnley Street and Assessor's Parcel Number (APN) 165-001-059.

Site Map

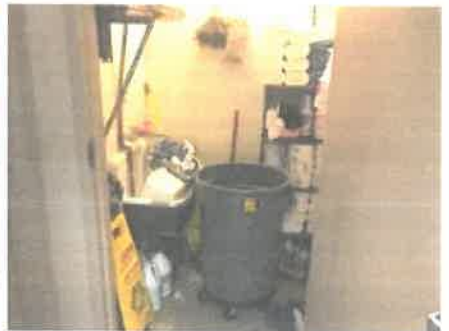
- The kitchen areas contain small quantities of household cleaning supplies.
- Multiple storage rooms on the subject property contain small quantities of disinfectant, steel polish, bleach, drain cleaner, and insect killer.
- An outdoor storage shed contains large quantities of paint buckets, paint cans and spray cans.
- An outdoor metal storage container contains 5-gallon buckets of driveway sealer, roof leak repair sealant, and a flammable storage cabinet containing two small portable fuel canisters.

Photograph 6. View of a storage room located in the Administration Building.

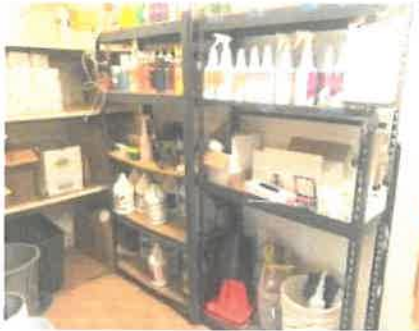
Photograph 7. View of a storage room containing cleaning supplies located in the Community Center Building.

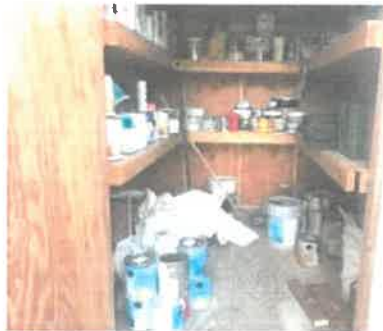
Photograph 8. View of an outdoor storage shed containing paint containers.

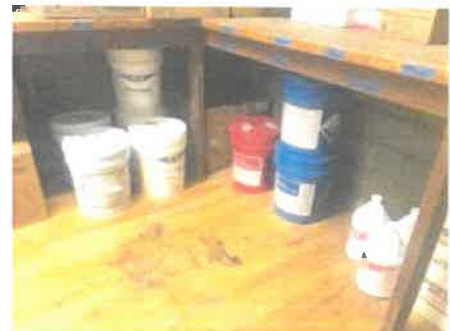
Photograph 9. View of a storage room containing floor sealant located in the Community Center Building.

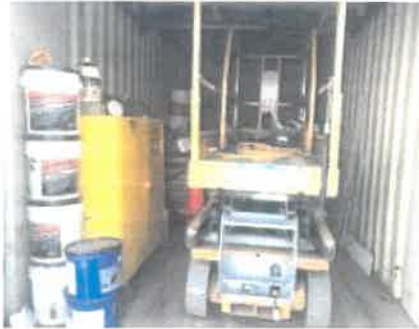
Photograph 10. View of an outdoor metal storage container with driveway and roof sealant and a flammable storage cabinet.

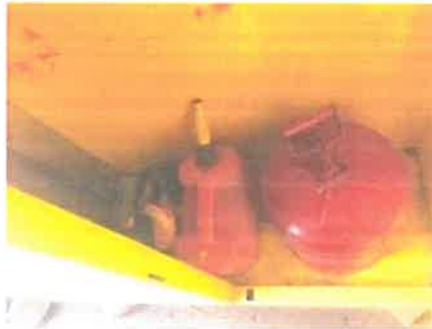
Photograph 11. View of the flammable storage cabinet containing small portable fuel containers.

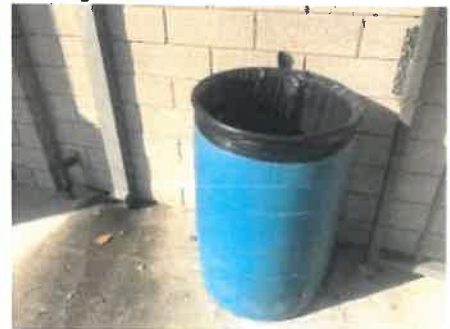
During the site reconnaissance, we observed various empty plastic drums on the subject property. Mr. Cerasuolo indicated that all the drums observed on the subject property are in use as trash cans. No other drums were reported by the site representative or observed during the site reconnaissance. Rincon did not observe indications of releases from the drums on the subject property.

Photograph 12. View of a plastic drum in use as a trash can.

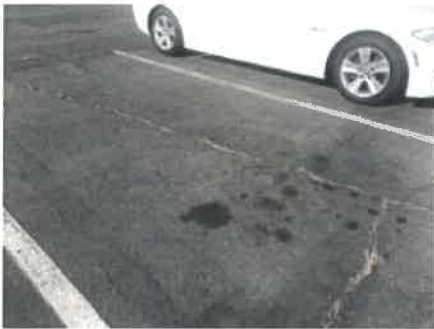
Stained Pavement. During the site reconnaissance, surficial motor oil staining (from parked vehicles) was observed within the asphalt-paved parking lot area on the subject property.

Photograph 13. View of surficial staining on asphalt located in the parking lot area on the subject property.
